Indoor air sealing of the parish center | Hämeenlinna

Indoor air repair of office premises. The repair includes measures to improve the ventilation and the sealing repair of the windows to the frame structures. Quality control was performed with tracer tests and indoor air measurements.

Kunde: Poltinaho parish center

Mål: Indoor Air Sealing

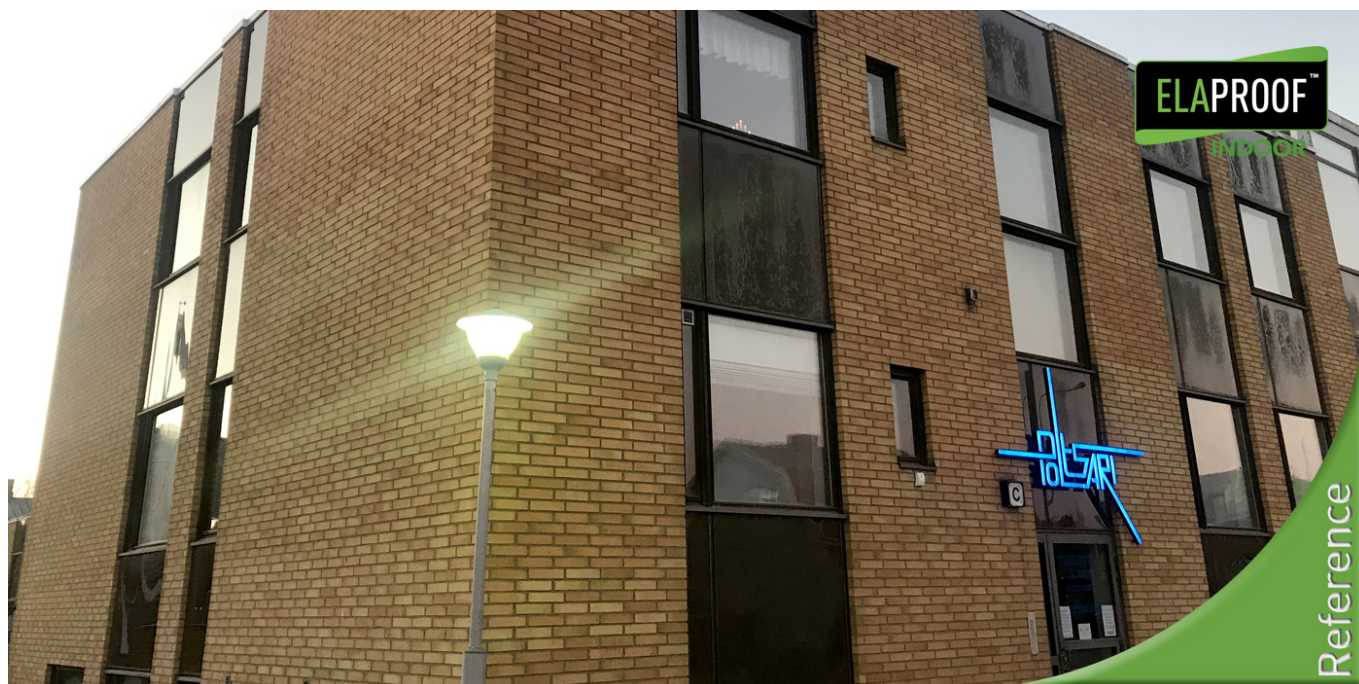
Typical 1980s concrete-wool-brick frame with mechanical exhaust ventilation. The replacement air valves are incomplete and partially unmaintained. Part of the replacement air comes through wetted insulation between the window frame and the wall frame, causing mineral wool fibers in the indoor air and health hazards caused by microbial damage. In the repair, controlled replacement air paths were added and the window frames were sealed to the wall frame.
