# Indoor air sealing of a townhouse apartment

## Arbeidserklæring

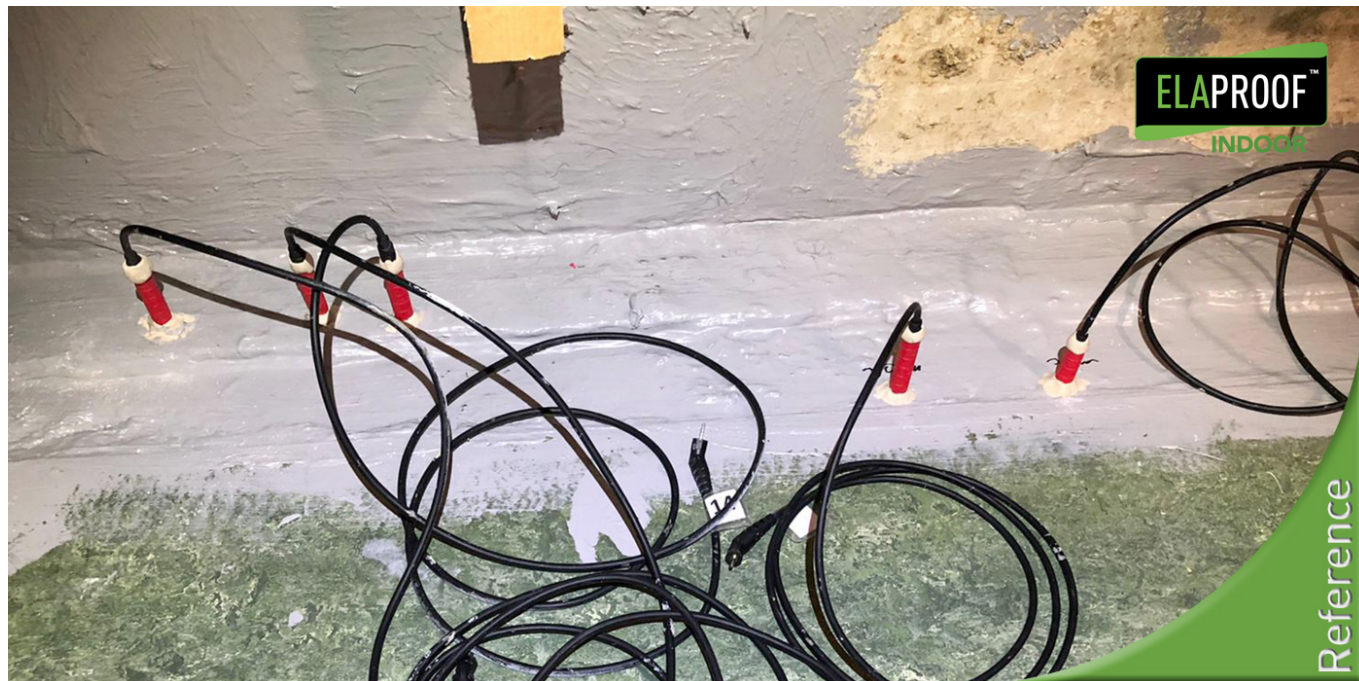
A microbial odor was detected in the indoor air of a townhouse apartment, the cause of which turned out to be a leak coming from the soil at the border between the floor and the plinth. Structure opened and microbial odorous materials removed and air leakage sealed with ElaProof Indoor. The space has been dust cleaned and ozonated. The moisture content of the structure was measured with structural moisture measurements. The renewal of the structure was carried out according to the plans.
