# Indoor air sealing of office spaces | Lappeenranta

**Project:** Indoor Air Sealing

**Address:** Lappeenranta, Finland

**Time and city:** 12/2020 | Lappeenranta

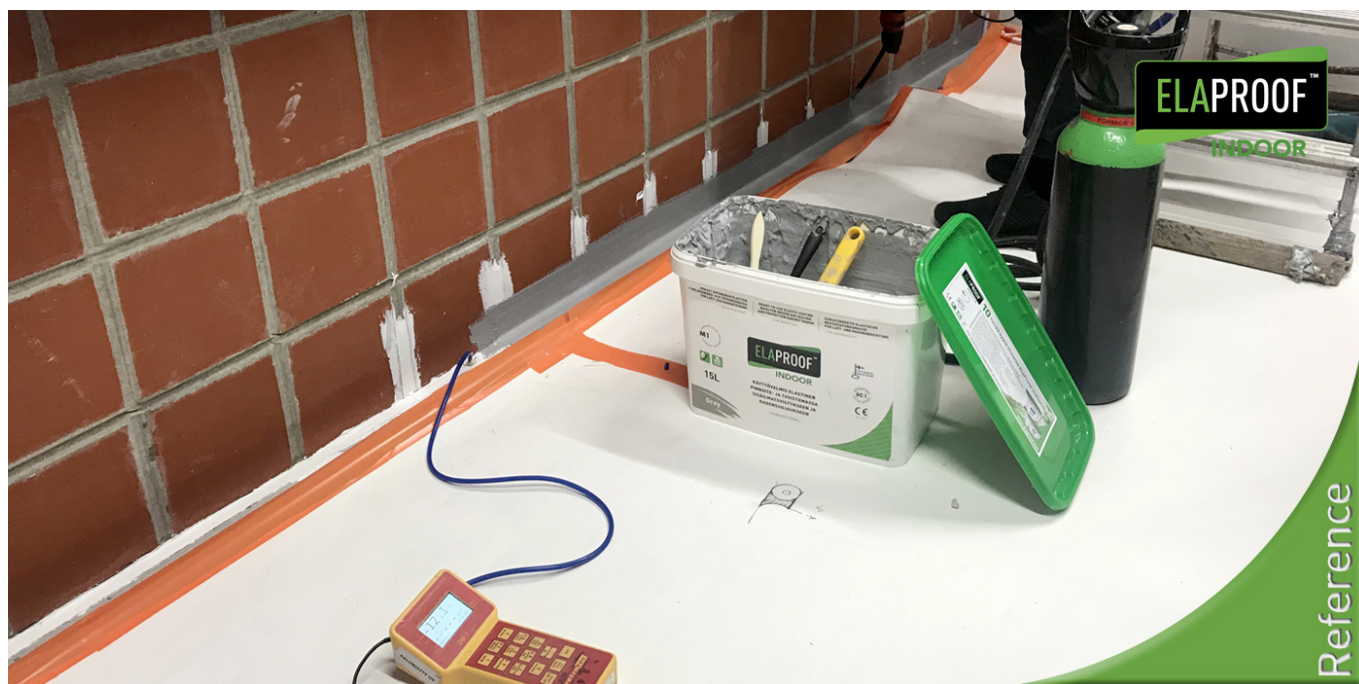
The site has a typical 1980s concrete-wool-concrete frame. The tightness of the recasts of the element joints is insufficient. By repairing them, better indoor air quality, improved thermal comfort and the building physical function of the structures are achieved.

The indoor air repair of the office premises was carried out with ElaProof products. The repair included sealing repairs to the frame structures. The goal is to secure good indoor air by repairing the element seams of the outer wall element. Quality control was performed with tracer tests. Lifetime target: 20 years
