Indoor air sealing of a townhouse apartment

Project: Indoor Air Sealing

Contractor: Paloniitty Oy

Time and city: 08/2020 |

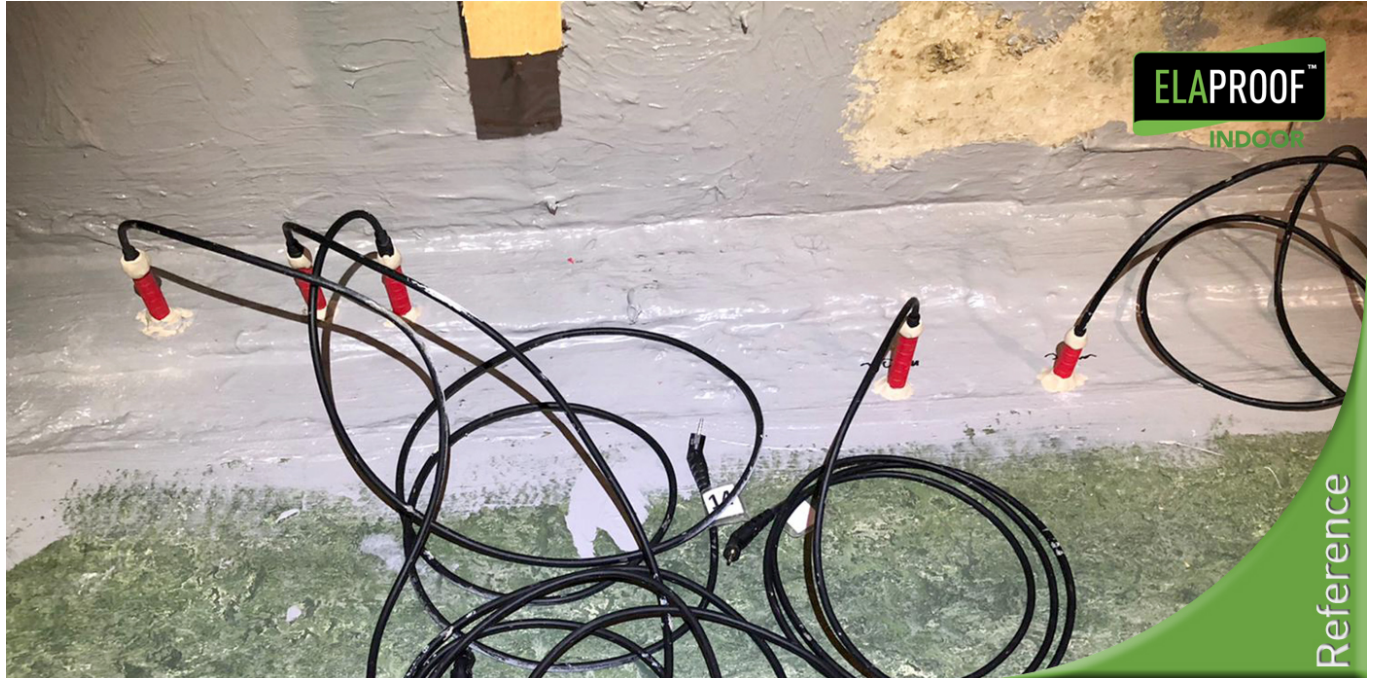
A microbial odor was detected in the indoor air of a townhouse apartment, the cause of which turned out to be a leak coming from the soil at the border between the floor and the plinth. Structure opened and microbial odorous materials removed and air leakage sealed with ElaProof Indoor. The space has been dust cleaned and ozonated. The moisture content of the structure was measured with structural moisture measurements. The renewal of the structure was carried out according to the plans.
