Machine seam ceiling 370 m² | Turku

Project: Roof coating

Address: Kaskenkatu 4b, 20700 Turku, Finland

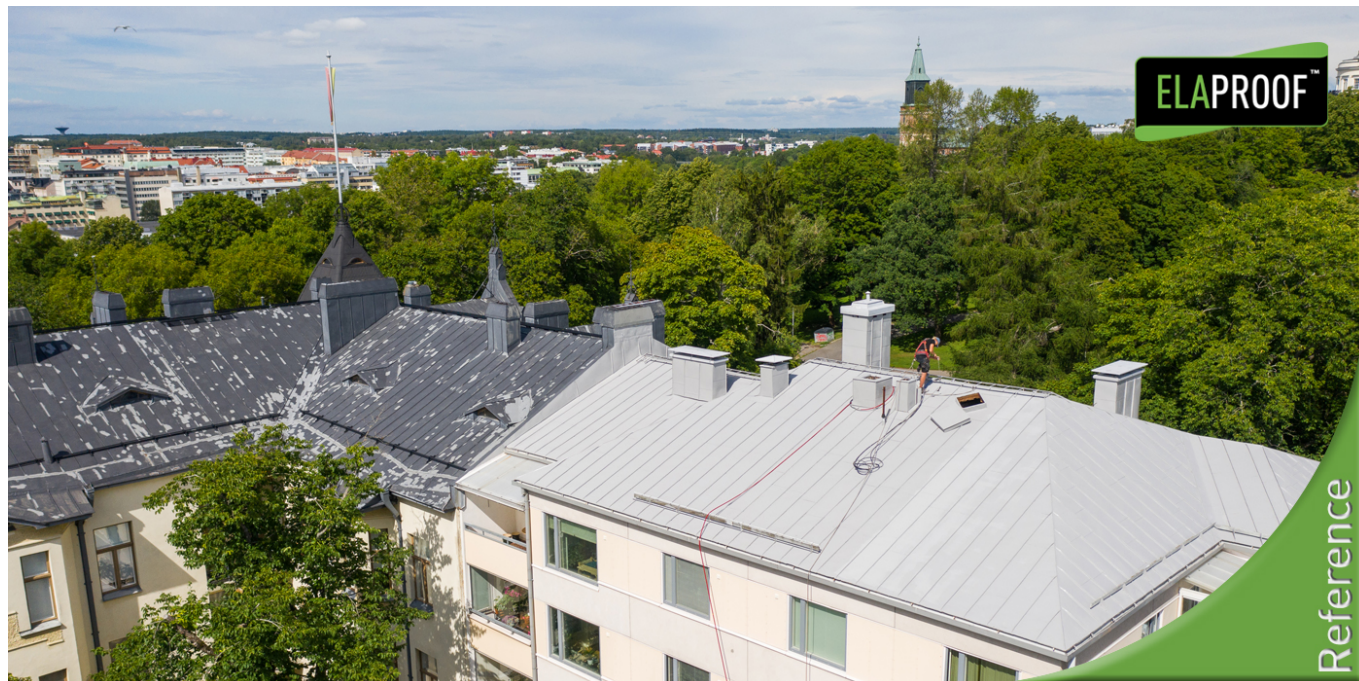
The site has a leaking and rusty machine seam roof. Before spraying Elaproof on the roof, I performed hot high-pressure washing and sanding of rust spots and pretreatment. The site was sprayed with Elaproof S twice according to the work instructions.
