Base floor repair of a Single-family house

Project: Indoor Air Sealing + Radon barrier

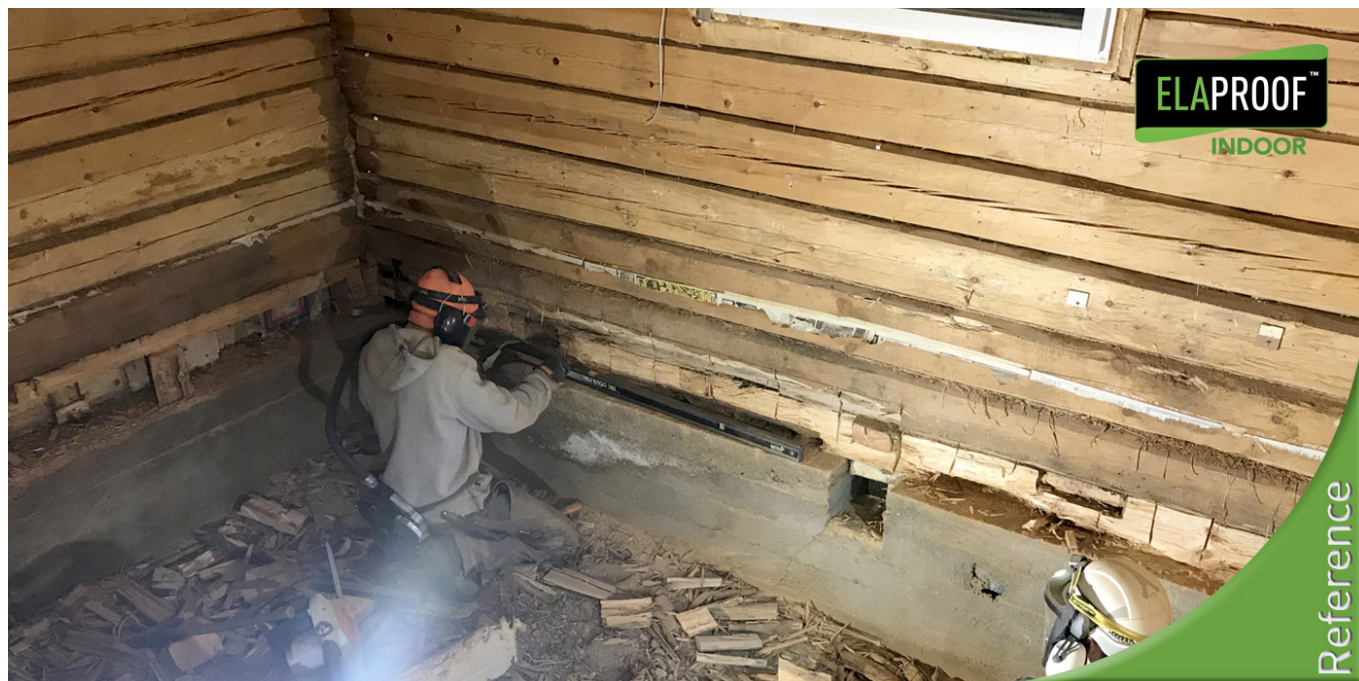
The base floor of the 1940s house was microbially damaged. The floor was taken down and the subfloor was repaired into a modern heat sink. An 8-16 mm capillary garland was installed against the ground. EPS insulation 200 mm was installed on top of it. The seams of the insulation were sealed with Elaproof. The tightness was confirmed by tightness measurement and thermal imaging. There is mechanical ventilation and room heating under the floor of the house. Insulation and Elaproof also acts as a radon barrier.
