## Machine seam roof 1200 m<sup>2</sup> | Helsinki

**Project:** Roof coating

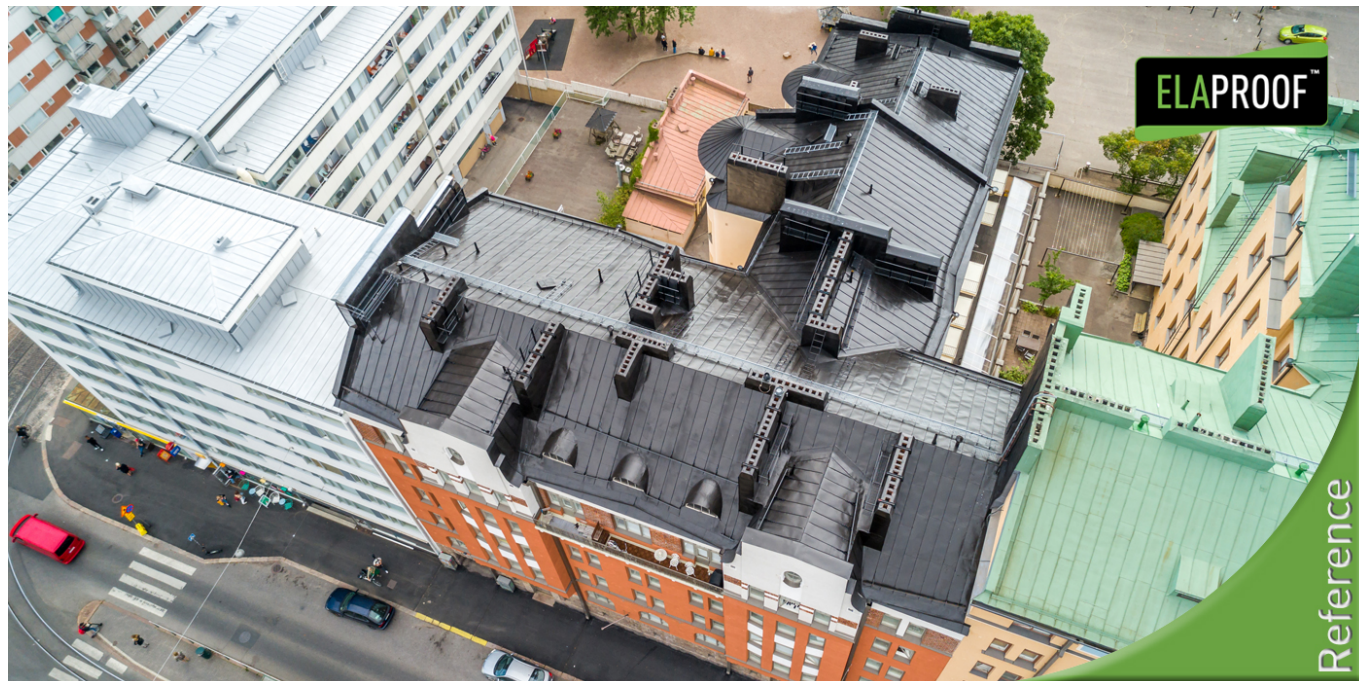
Before coating, the roof was carefully washed. In this demanding site, part of the roof had e.g. old graphite paint that was removed by dry ice blasting. Before spraying, the seams and joints were sealed with ElaProof H. The roof was sprayed with ElaProof S twice according to the work instructions.
