## Machine seam roof 1200 m² | Helsinki

**Project:** Roof coating

**Contractor:** JJ-Kattohuolto Oy

**Time and city:** 06/2019 | Helsinki

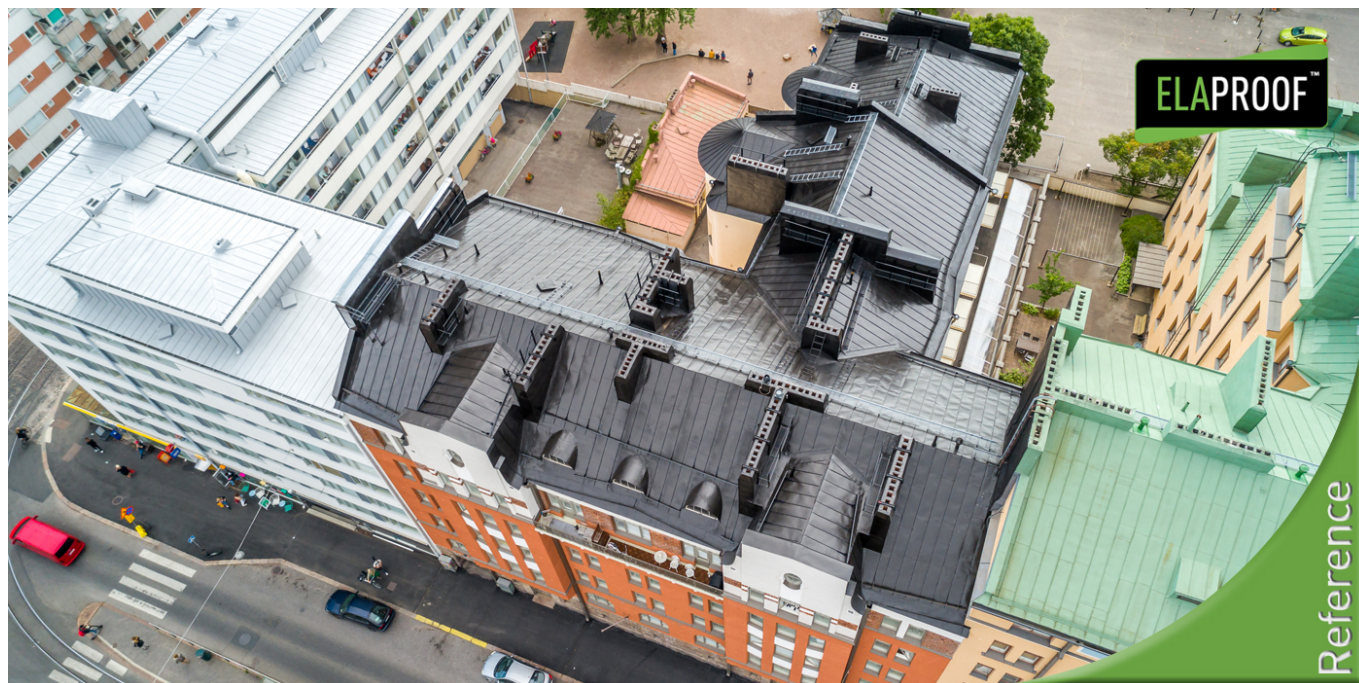
Before coating, the roof was carefully washed. In this demanding site, part of the roof had e.g. old graphite paint that was removed by dry ice blasting. Before spraying, the seams and joints were sealed with ElaProof H. The roof was sprayed with ElaProof S twice according to the work instructions.
