Indoor air sealing of the school building | Forssa

Project: Indoor Air Sealing

Time and city: 06/2020 | Forssa

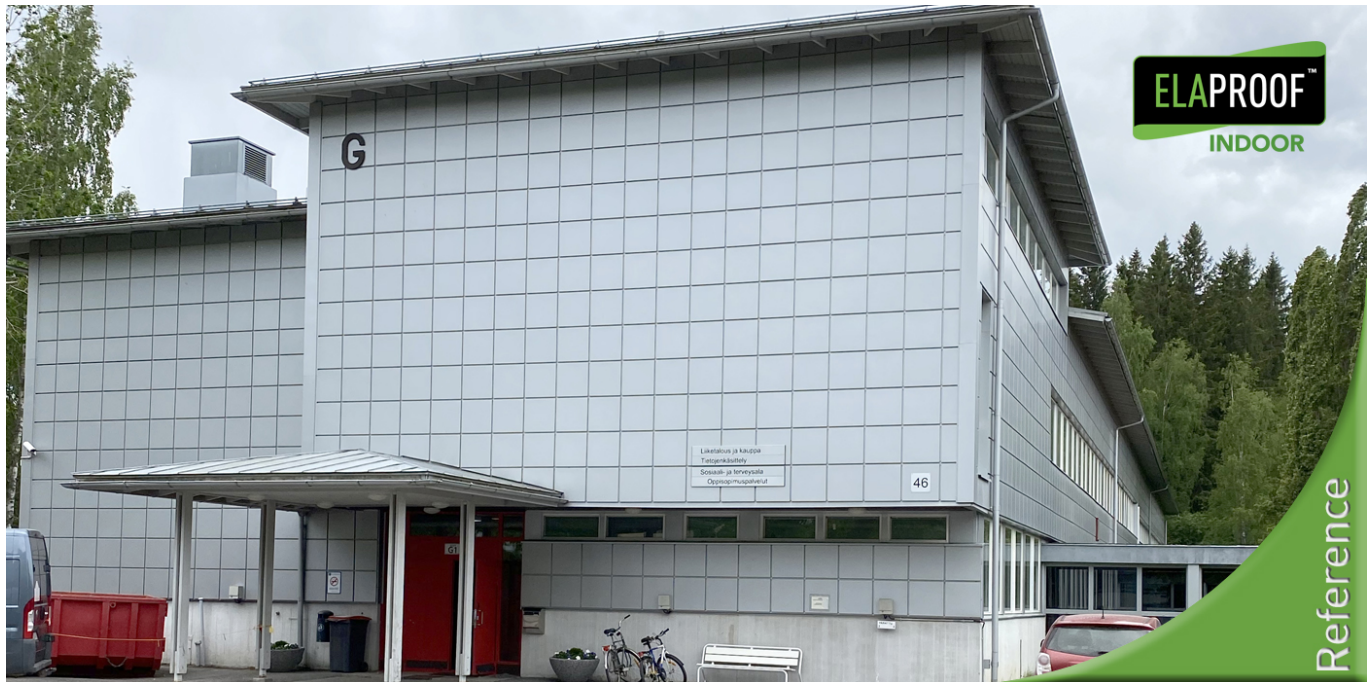
The school building has indoor air pollution and heat leaks. Floor moldings removed from the structures and larger gaps sealed with Masa sealing compound before ElaProof Indoor installation. Model sealing made after ElaProof Primer treatment, which was checked with tracer tests before starting the actual sealing work. The work has been carried out in accordance with Paloniitty Oy's plans and the work instructions of the product manufacturer.
