# Machine seam roof, Kindergarten 900 m<sup>2</sup> | Helsinki

## Description

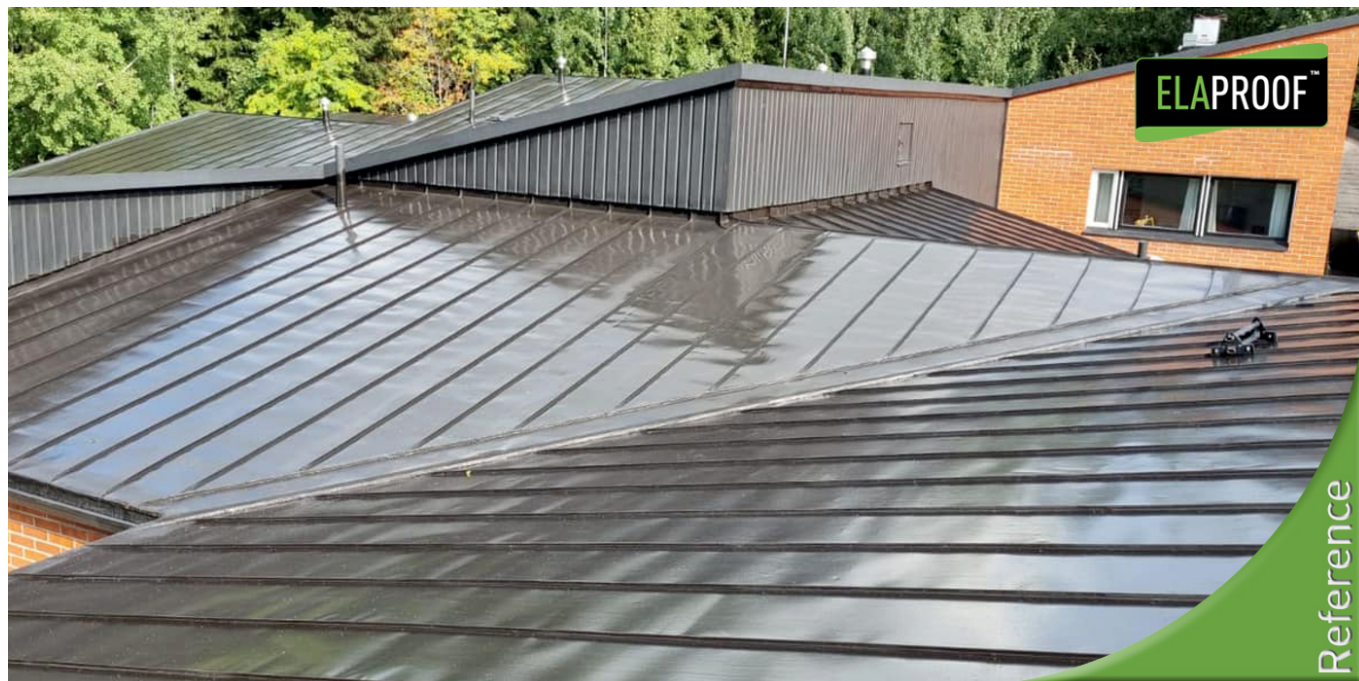
Niitty, a kindergarten in the city of Helsinki, was coated with ElaProof S according to the manufacturer's instructions twice. This ensured a minimum dry film thickness of 0.6 mm in terms of waterproofing.

In connection with the coating work, the holes caused by removing the old snow barriers were patched with ElaProof H and Base fabric. In addition, the vertical seams of the long miters were treated in the same way. The ventilation of the roof was improved with vacuum fans hand-made by a sheet metal worker. After the coating work new snow barriers, roof bridges and ladders were installed.
