## Eurogum / Felt roof 3000 m<sup>2</sup> | Lieto

### Arbejdserklæring

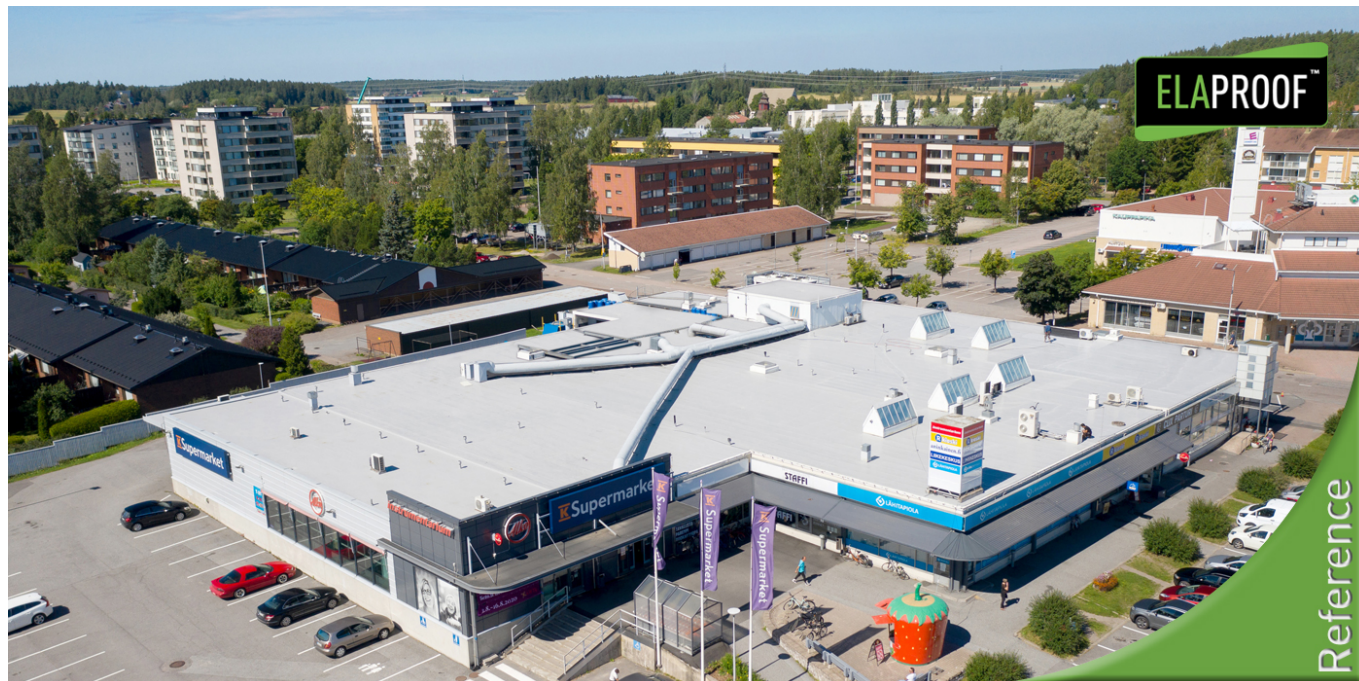
Two different roof materials are used in Lieto: Eurogum and felt roof. The roof materials have a lot of cracks, breaks and penetrations in poor condition. Hot high-pressure washing of the roof was carried out at the site, the penetrations were pre-treated with ElaProof H and ElaProof Base fabric. The ceiling was coated twice with gray ElaProof S.
