Indoor air sealing of the school building | Forssa

Arbejdserklæring

Mål: Indoor Air Sealing

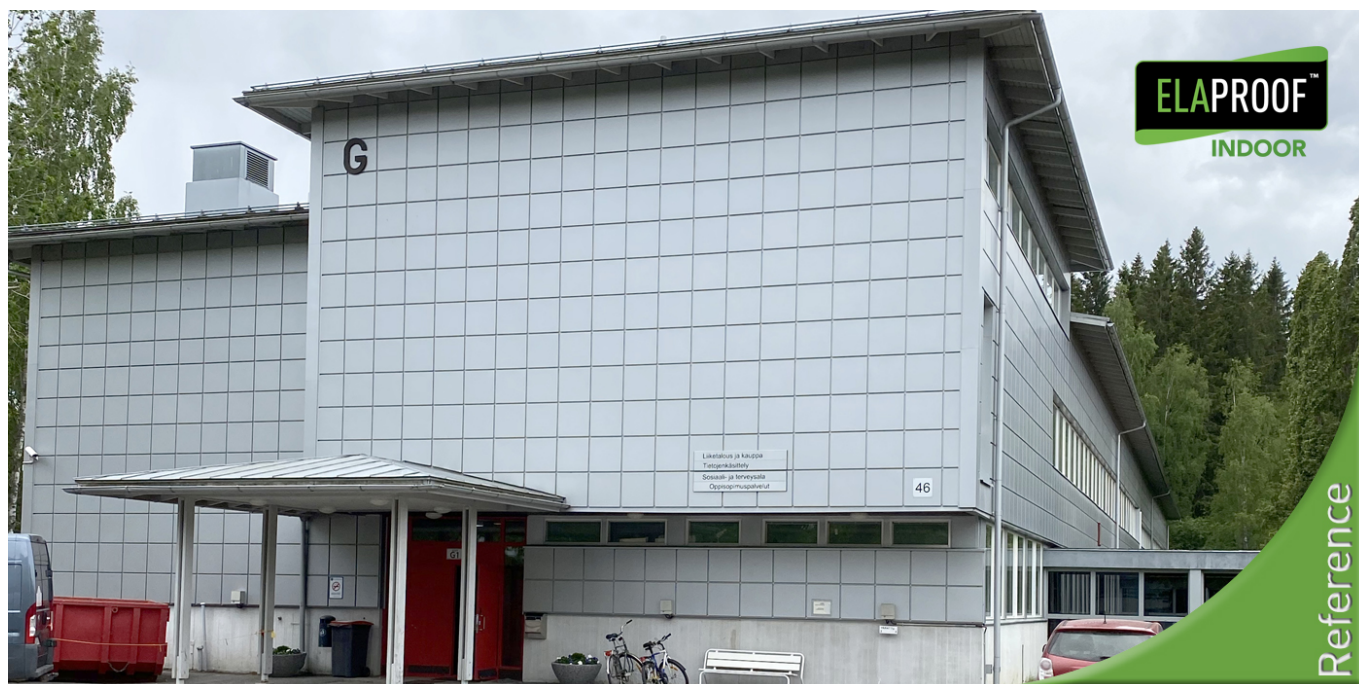
The school building has indoor air pollution and heat leaks. Floor moldings removed from the structures and larger gaps sealed with Masa sealing compound before ElaProof Indoor installation. Model sealing made after ElaProof Primer treatment, which was checked with tracer tests before starting the actual sealing work. The work has been carried out in accordance with Paloniitty Oy's plans and the work instructions of the product manufacturer.
