Coating of the roof terrace 40 m² | Tuusula

Arbeidserklæring

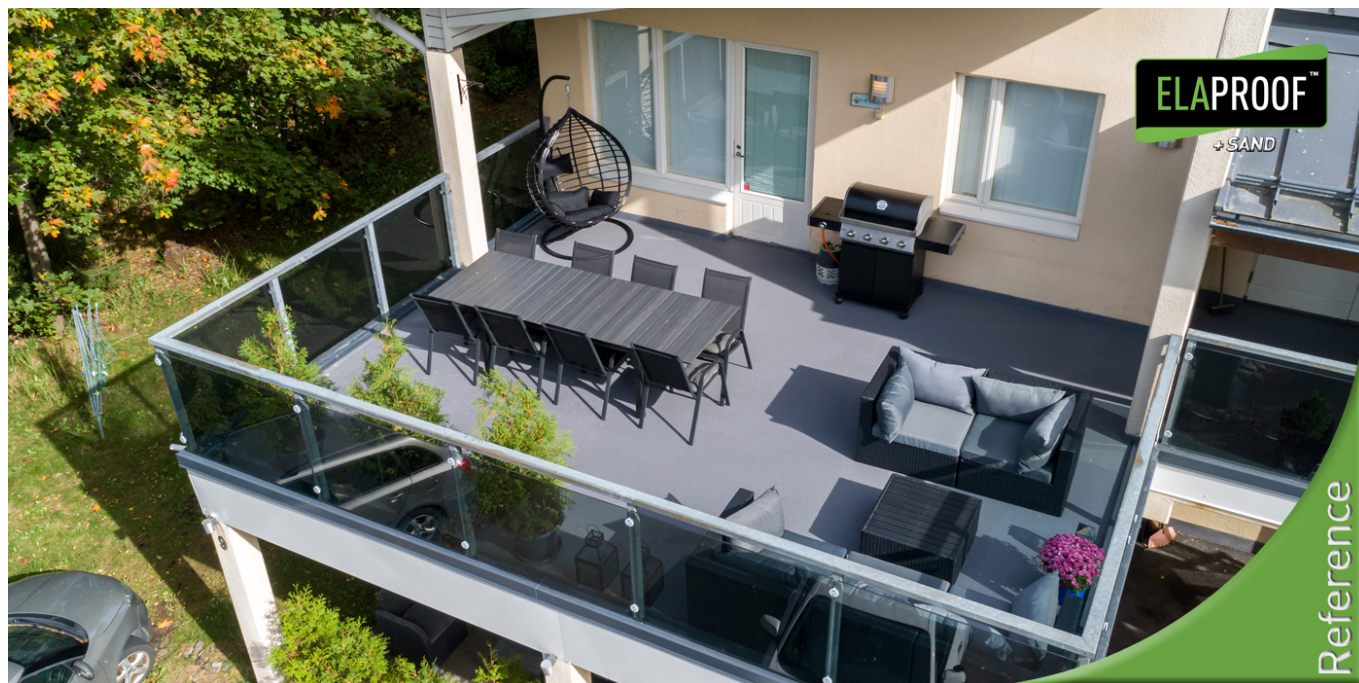
The 17-year-old roof terrace floor of the town house was in very poor condition. Moisture had penetrated under the tiles, because the waterproofing had failed, and the structure under the terrace was wet all over. After lengthy drying and foundation work, the waterproofing was brought to a modern level with ElaProof H. The customers wanted an easy-to-maintain and stylish floor surface, so they chose ElaProof+SAND Floor Coating, over which ELACOAT TopCoat 2-component colorless varnish was installed.
