Balcony waterproofing | Tuusula

Arbeidserklæring

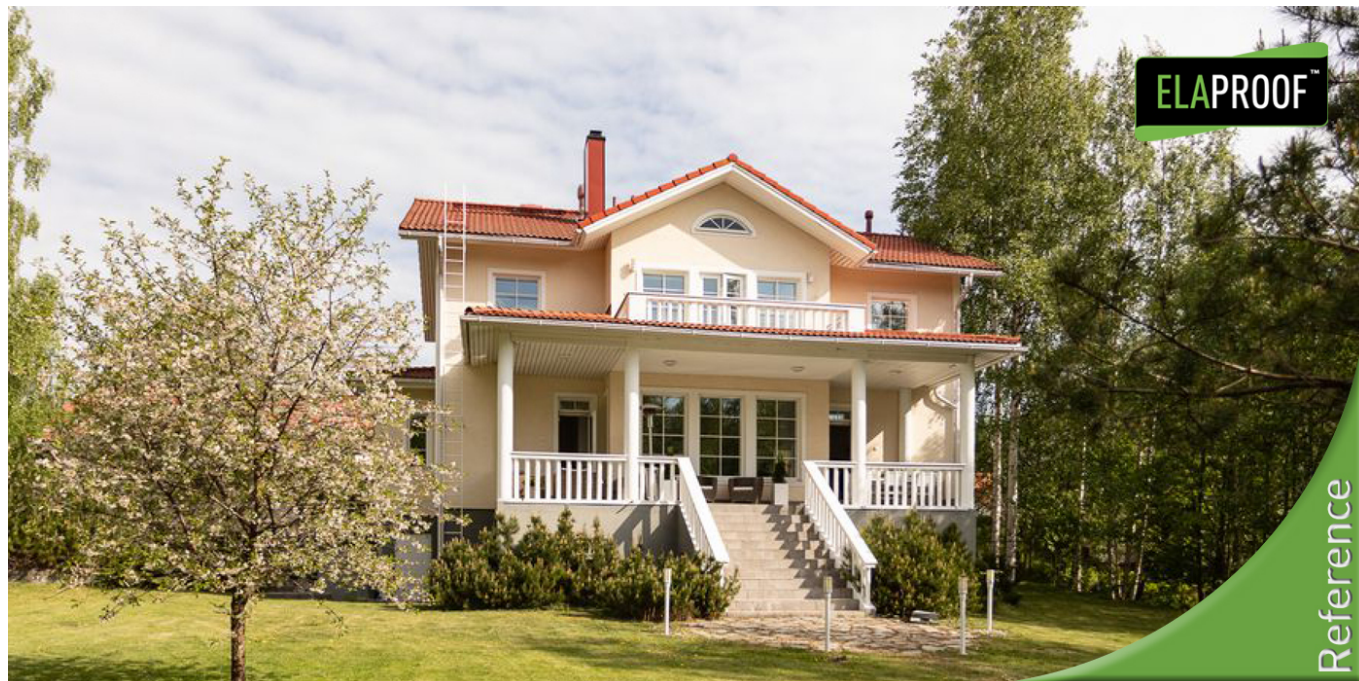
There are leaks in the wall-floor connection of the balcony on the upper floor of a detached house to the lower floor. The old tiling was removed from the site and the balcony was leveled – ElaProof Primer was applied to the base. The boundary points of the wall-floor interface were treated with ElaProof H using ElaProof Base Fabric. The entire terrace was waterproofed with ElaProof H before tiling.
