Terrace coating 30 m² | Savonlinna

Arbeidserklæring

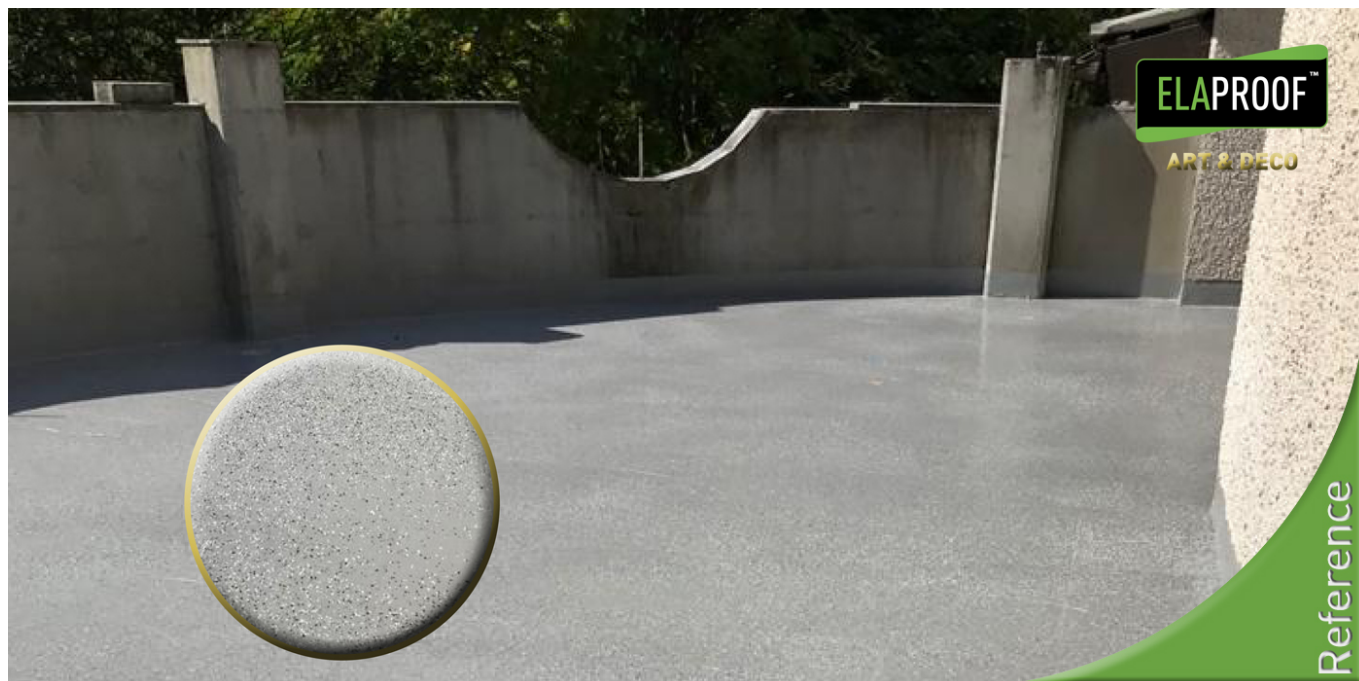
The terrace of a detached house, old tiles, some marble and some granite. The surfaces of the tiles were sanded open with a cup wheel. The surface was treated with ElaProof Primer before coating. Waterproofing was ensured with ElaProof H and ElaProof Art&Deco 3-color flakes was applied to the surface. The final surface was protected with ELACOAT TopCoat varnish.
